Call RFCS-2022 Project number 101112657

# **Deliverable 3.4**

# Report on characteristics of post-mining reclamation case study areas

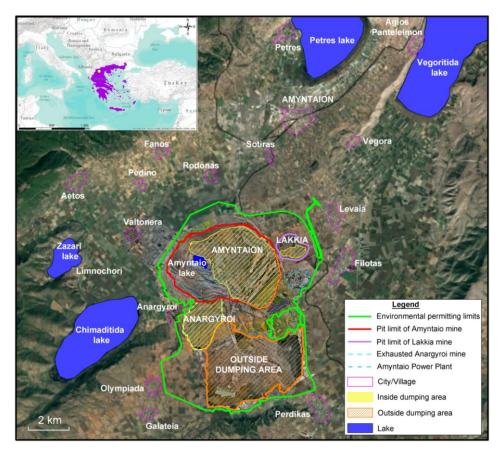
Figure 1. The location of Amyntaion mines (Anargyroi, Amyntaion, Lakkia) within the environmental permitting limits (Kavvadas et al., 2022).

Figure 1 shows the current conditions with the spatial configuration of the waste dumps (inside and outside). Inside dumping was conducted mainly with spreaders (continuous surface mining) and, in some cases, with trucks and loaders (non-continuous surface mining). The internal waste dumps are estimated at  $\approx$  725 million m3. Currently, the region's economy depends on agriculture and energy fuel reserves. Figure 3 presents the current condition of the Amyntaion mining area, where the already reclaimed forest and cultivated areas are depicted, as well as the graded areas which are intended to host photovoltaic parks. The land use map regards the area of 45.18 km2 where the mining operations were taken place.

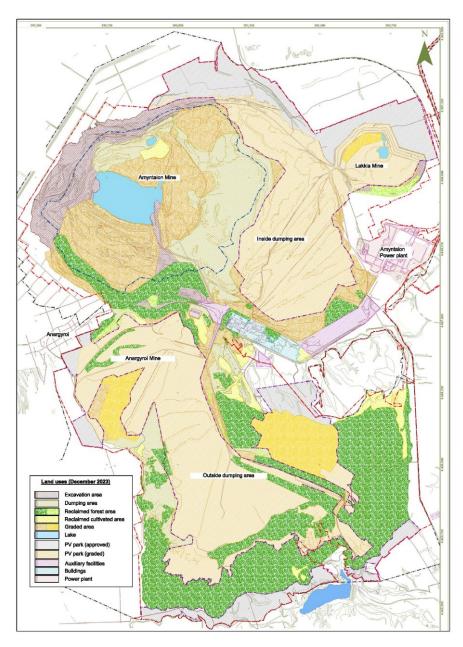
Figure 3. Allocation map of the existing land uses in the Amyntaion mining area (Technical Report of PPC, 2024)

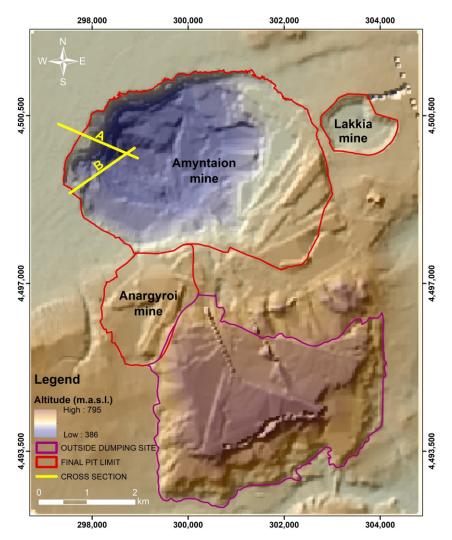
Figure 5. Digital Elevation Model (December 2021) of the Amyntaion mining area, showing the three main mines (Anargyroi, Amyntaion and Lakkia). (Kavvadas et al., 2022) Elevations are shown in hillshade effect.

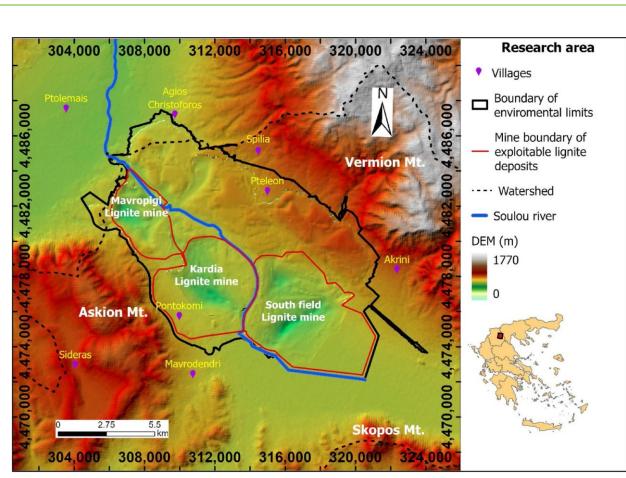
Figure 7. Digital Elevation Model of the Ptolemais mining area (Louloudis et al., 2023)

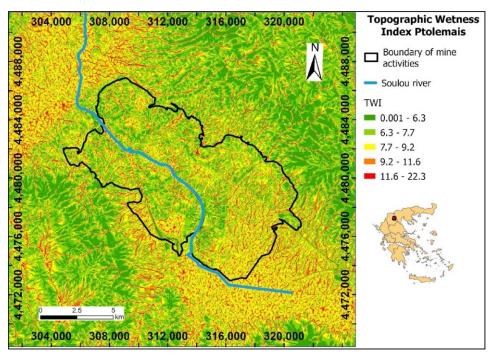
Figure 8. Spatial distribution of TWI with the combinations of two DEMs in 2022 where drainage networks are shown in red colour, (Ptolemais Basin, northern Greece). (Louloudis et al. 2023 The area of mining activities is indicated in black)

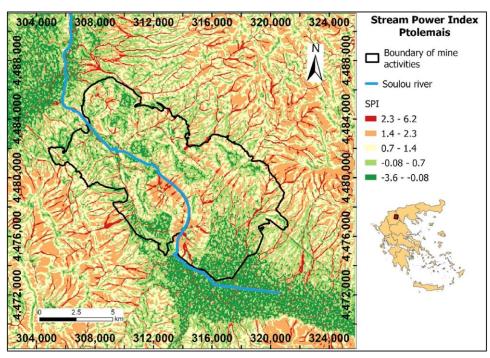
Figure 9. Spatial distribution of SPI with the combinations of two DEMs in 2022 where the high velocity of the streams is presented with red values (Ptolemais Basin, northern Greece). (Louloudis et al. 2023) The area of mining activities is highlighted in black

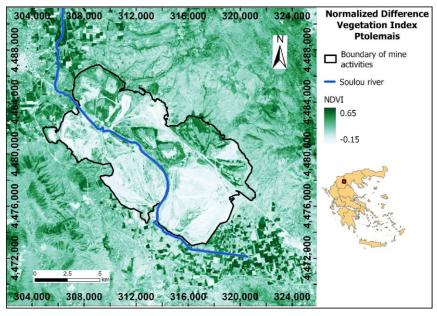
**Figure 10.** Spatial distribution of NDVI in July 2022 (Ptolemais Basin, northern Greece). (Louloudis et al. 2023) Higher values of NDVI suggest healthy and dense vegetation while lower values non-vegetated-surfaces

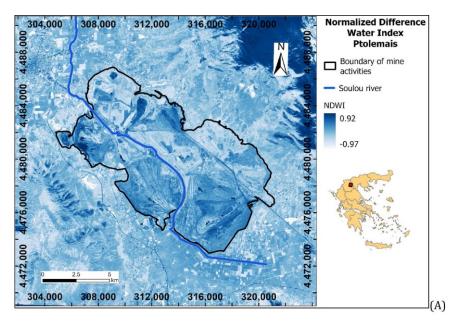
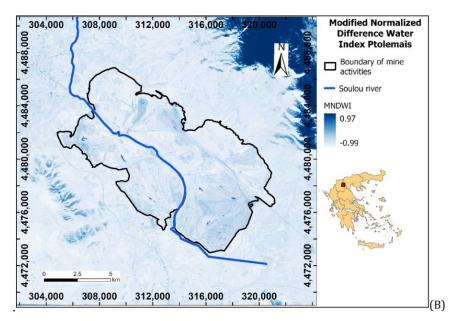
Figure 11. Spatial distribution map of NDWI (A) and MNDWI (B); indices ranging from + 1 to −1 recorded in December 2021 (Ptolemais Basin, northern Greece). (Louloudis et al. 2023) Water features are represented by dark blue colour. The area of mining activities is outlined as black line

Figure 11 cont. Spatial distribution map of NDWI (A) and MNDWI (B); indices ranging from + 1 to −1 recorded in December 2021 (Ptolemais Basin, northern Greece). (Louloudis et al. 2023) Water features are represented by dark blue colour. The area of mining activities is outlined as black line

shown in the southern area of the South Lignite Mine. The NDWI of Figure 11A shows the water features which are accumulated in locations with a high potential for inundation, while Figure 11B shows an improved NDWI, without noise from the urban areas.

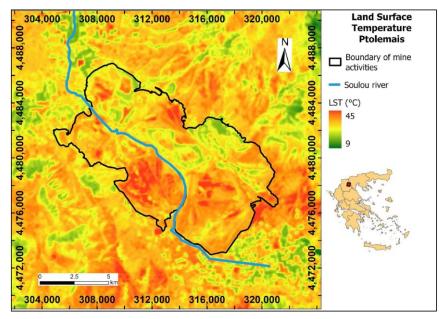
Figure 12. Spatial distribution of temperature in July 2022 (Ptolemais Basin, northern Greece). (Louloudis et al. 2023) The area of mining activities is shown

Figure 12 presents the Land Surface Temperature spatial distribution map in July 2022, where high temperatures are observed inside the mine sites. The mean temperature value was 34 °C, while the temperature recorded at that time ranged from 9 to 45 °C.

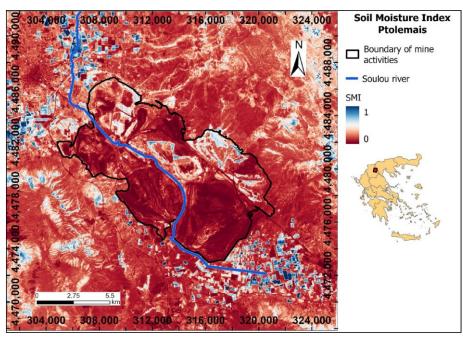
Figure 13. Spatial distribution of SMI in July 2022 (Ptolemais Basin, northern Greece). (Louloudis et al. 2023) High soil moisture values are indicated by blue colour, representing agricultural fields and forests. The area of mining activities is shown

The mapped SMI distributed values (Figure 13) illustrate spots of high soil moisture values (the blue areas), in the areas outside the mine, representing agricultural land cover. The area outside of the waste rock dumping, i.e., north of the South Lignite Field and within the boundary of mining activities, also has high soil moisture. This is due to small forests as land cover, which were build up over the past years of reclamation activities.

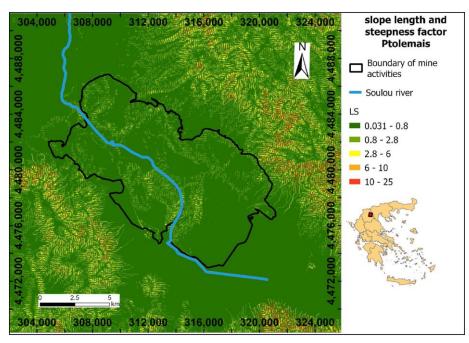
Figure 14. Spatial distribution of LS where high erosion is indicated by red colour (Ptolemais Basin, northern Greece). (Louloudis et al. 2023) The area of mining activities is shown in black

The slope length and steepness factor are indicators which calculate the soil erosion based on Digital Elevation Model (DEM). The distribution of LS values (Figure 14) for Ptolemais area indicates that water discharge is evident only in the mountains. At the same time, lower calculated values are scattered inside the boundary of the mining activity and in the agricultural area outside the mines. An important issue is the weathering intensity, which is more pronounced around Vermion Mtn.

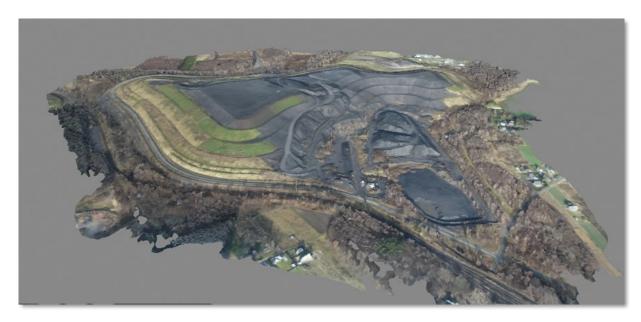
Figure 16. Current relief of Północ Waste Heap

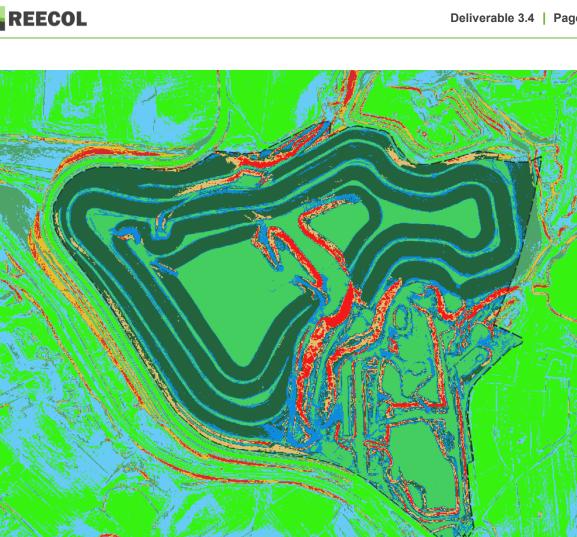
Figure 17. Participation of degree of land degradation in terms of potential stability loss

The terrain with slopes less than 5°, is primarily located on the tops of the waste heap. Formed slopes with degrees between 15° and 26° cover 41.5% of the heap's area. An exemplary visualization of the degradation of the site in terms of potencial to stability loss can be seen in the table and figure below. The figure illustrates how different slope classes contribute to the overall morphology and degradation of the Jankowice Waste Heap.

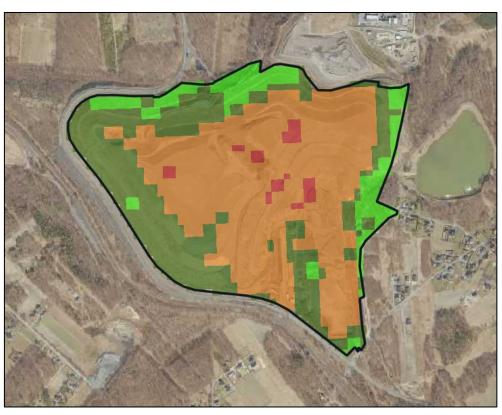
Figure 18. NDVI Indicator, Północ Waste Heap (27.07.2023)

The degree of site degradation was assessed on the basis of the NDVI indicator. In the case of the Waste Heap Jankowice Waste Heap, there are clearly visible areas with no vegetation and areas with only residual vegetation cover. Areas classified as high and medium degraded occupy over 55% of its area.. Index values above 0.4 were identified only on slopes covered with low vegetation, with the highest achieved in areas with trees growing at the base of the heap.

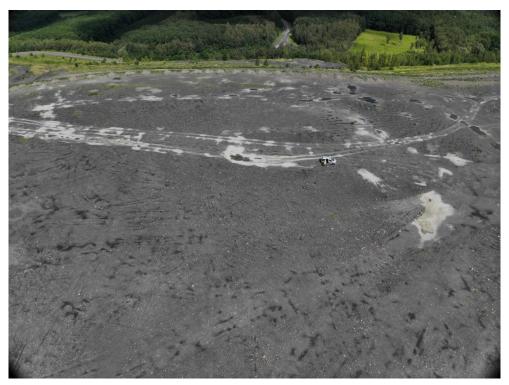
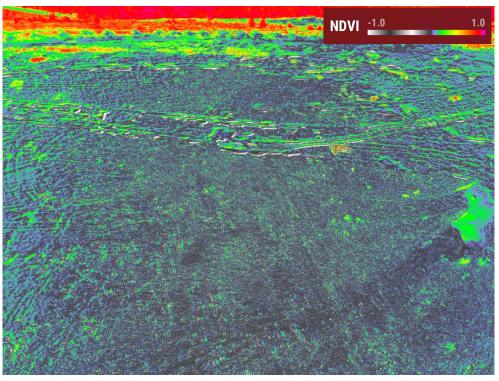
Figure 19. North view (1) of the planned reclamation area (visible light camera)

Figure 20. North view (1) of the planned reclamation area (actual value of NDVI index)

North view of the planned reclamation area is see on Fig. 19 (visible light camera) and Fig. 20 (NDVI index).

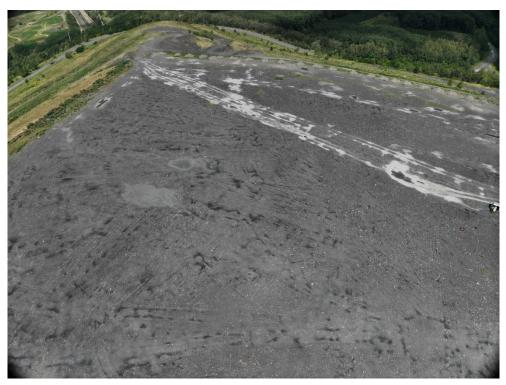
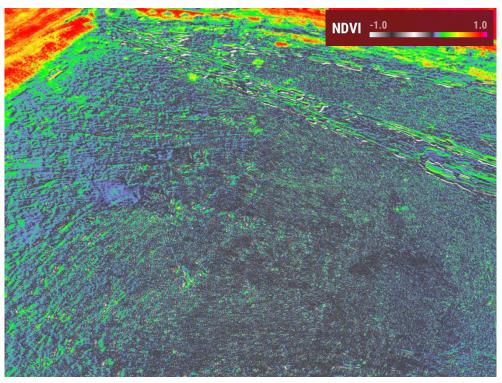
Figure 21. Northwest view (2) of the planned reclamation area (visible light camera)

Figure 22. Northwest view (2) of the planned reclamation area (actual value of NDVI index)

Northwest view of the planned reclamation area is see on Fig. 21 (visible light camera) and Fig. 22 (NDVI index).

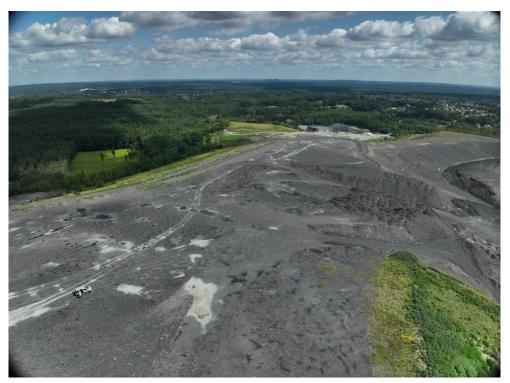
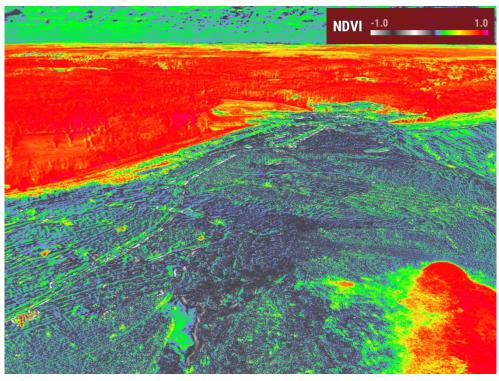
Figure 23. Northeast view (3) of the planned reclamation area (visible light camera)

Figure 24. Northeast view (3) of the planned reclamation area (actual value of NDVI index

Northeast view of the planned reclamation area is see on Fig. 23 (visible light camera) and Fig. 24 (NDVI index).

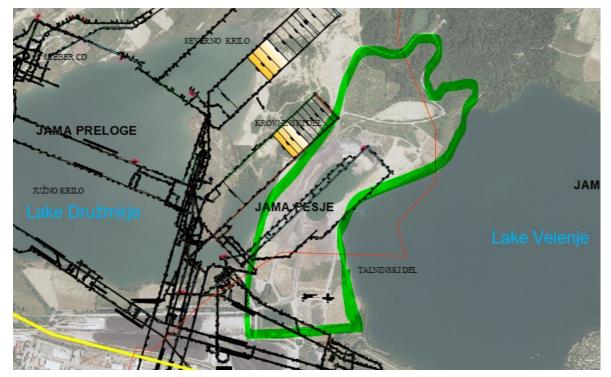
**Figure 27.** Subsidence remediation area PSU-within the green polygon. Black lines are underground mining objects. (Original PV archive)

subsidence at PSU, we use an average of 700,000 cubic meters of several materials, such as fly-ash and gypsum mixture (byproduct of nearby thermal power plant cleaning block is gypsum, fly ash is byproduct of burning coal in thermal power plant) and excavated materials (soil) from construction projects in vicinity.

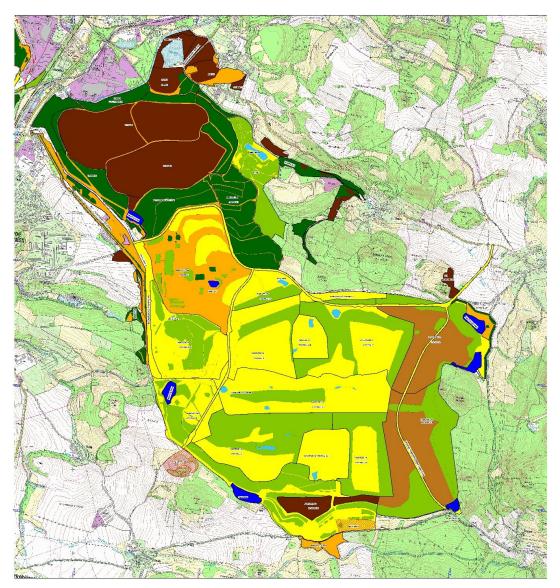
Figure 29. Schematic map of the planned and realised reclaimed areas of the Radovesice spoil heap

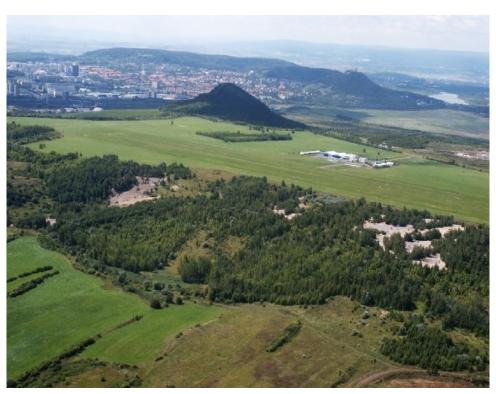
Figure 30. Situation of the reclaimed and succession areas of the Střimice spoil heap

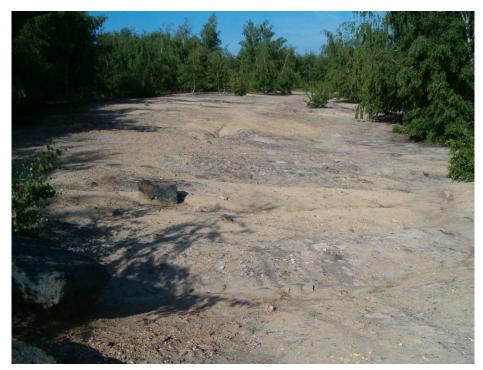
Figure 33. Succession area Střimice I

The research experimental area Střimice I with an area of 2 ha was enclosed in a small, non-reclaimed peripheral part of the Střimice landfill. The estimated age of the area is 45 years, research has been ongoing here since 1998. The predominant soil type here is a heterogeneous mixture of overburden soils from the coal seam formations of the Bílina open pit mine. Sandy clay loams and sands with a significant admixture of coal and siderite predominate. These are extremely acidic, phytotoxic soils (see Figure 33). A unique development of erosion grooves with a depth of up to several meters can be observed on the surface. This phenomenon is probably the most prominently developed here in the entire area of the Most Basin. Considering the extremely acidic character of the area, minimal plant representation was found here, but rare acid-loving species may occur.

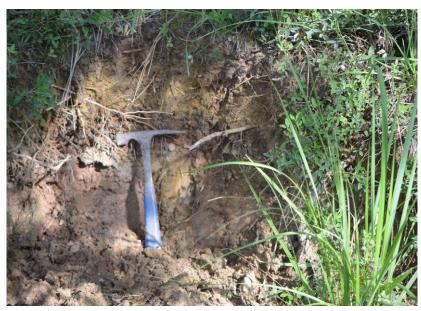
Figure 34. Soil profile with bentonite - Střimice II

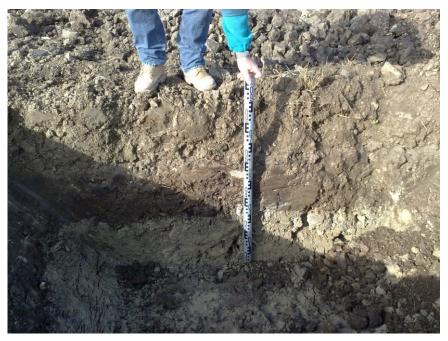
Figure 35. Monitoring the development of the soil profile in the reclaimed area

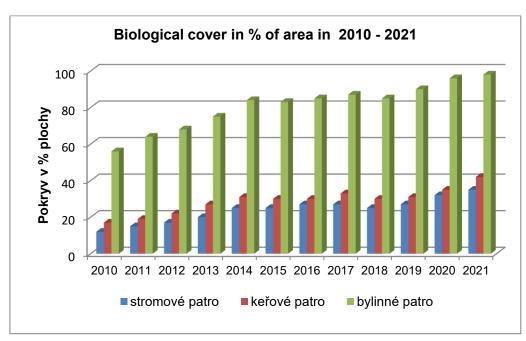
Figure 36. Temporal development of the biological cover of the succession area Radovesice

Despite some uncertainty in rainfall forecasts, the very dry period 2015 - 2019 with the extremely dry year 2018 is a warning. The dry period can also be seen in the results of the biological cover (tree, shrub and herbaceous level) research carried out on the succession area of Radovesice (see picture no. 36).

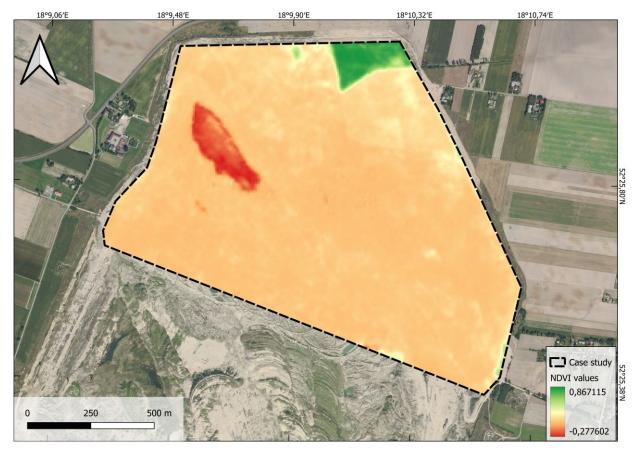
Figure 39. NDVI on case study in Jóźwin II B mine

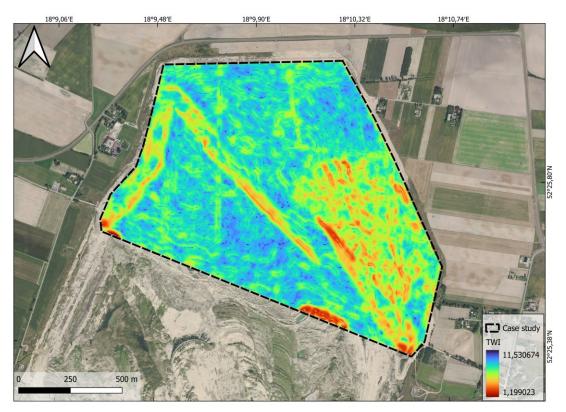
Figure 40. Spatial visualization of the TWI index in the studied area of the heap in the northern part of the Jóźwin IIB open pit.

The TWI (Topographic Wetness Index) helps identify places where water can potentially store, places of increased moisture. It is based on calculations on slope information. In the case studied, TWI was calculated spatially using SAGA software. The resulting visualization, however, allows only a visual determination of where such places are located (fig. 40). In order to analyze the exact number of places where water can potentially be stored (mostly concave or flat areas), a python library rasterio was used, on the basis of which a script was created and checked exactly how many pixels are located for a given value of the slope of the terrain (0-2 degrees of slope, fig. 41), as well as what values the TWI raster pixels take for the same points - based on these, the mean and median value (TWI ~8) were calculated (tab. 13). These were used to assume a value for flat terrain - that is, a limiting value above which TWI indicates potentially wet sites.

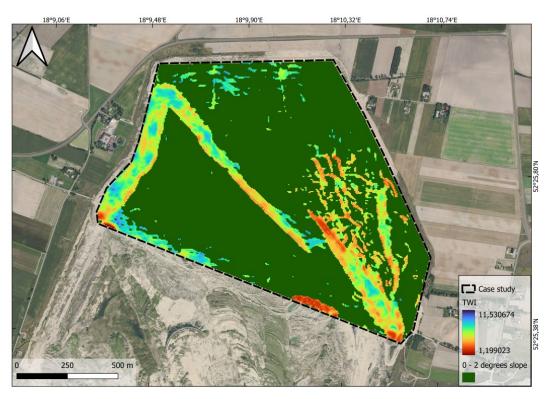
**Figure 41.** Spatial visualization of the TWI index in the studied area of the heap in the northern part of the Jóźwin IIB open pit with superimposed flat terrain mask.

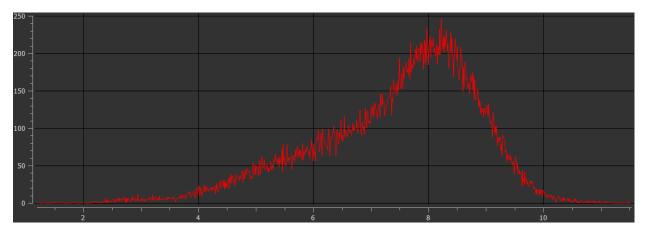
Figure 42. Histogram of TWI raster pixel values. As you can see, the peak of the values falls around TWI = 8 (Jóźwin II B)

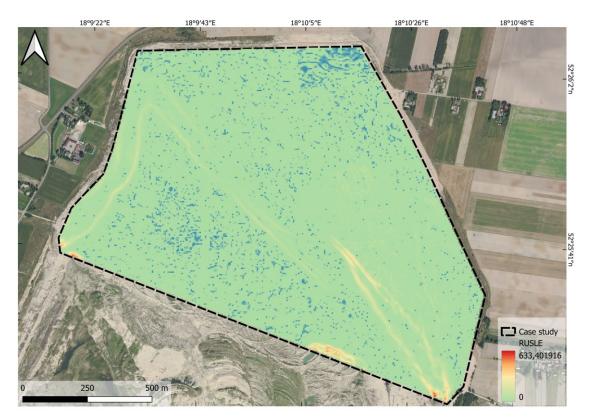
Figure 44. Spatial visualisation of RUSLE index. Blue means places where RUSLE ≤ 1.4

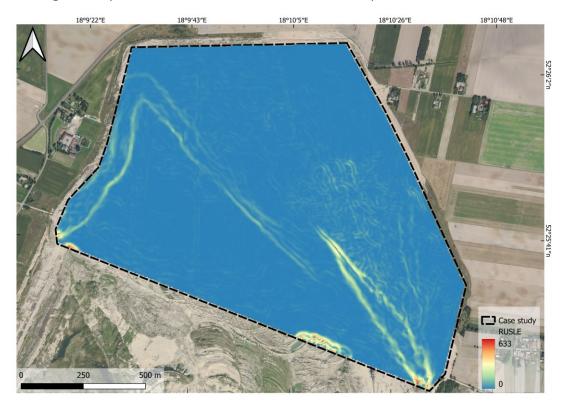
Figure 45. Spatial visualization of RUSLE with highlithed steep slopes, which are places with top RUSLE values

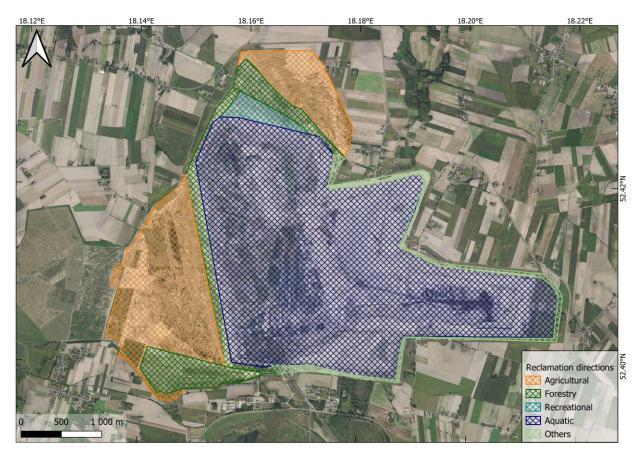
Figure 46. Spatial presentations of reclamation directions on Jóźwin IIB open-pit mine

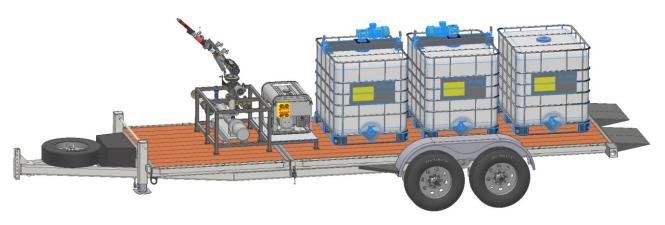
Figure 48. Non-contact soil remediation system - model 3D

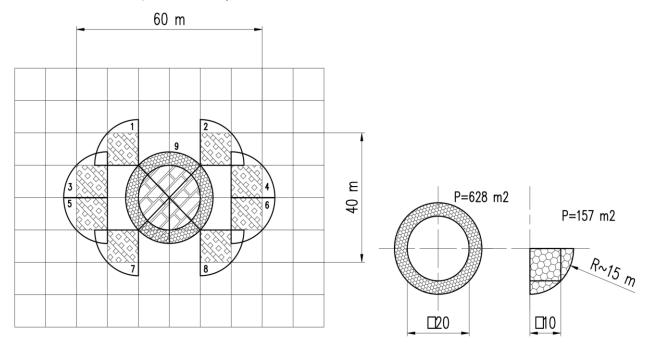
Figure 49. Minimum dimensions of the test field, allowing to perform 9 - iu test variants of the developed technology

To test this technology, a test field of  $60m \times 40m$  was established, allowing for the evaluation of the device's efficiency and performance, as well as the impact of different reclamation phases on plant growth. This field is divided into  $10m \times 10m$  quarters to study nine different test variants.

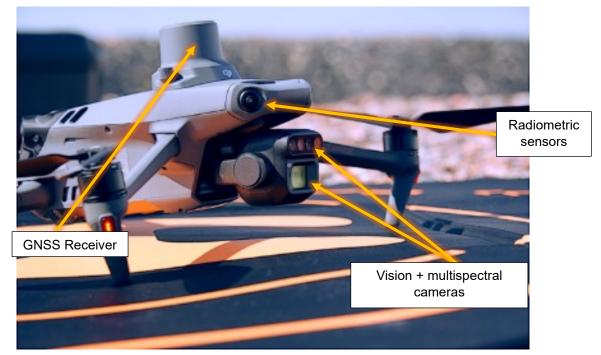
Figure 50. DJI Mavic 3 Multispectral with equipment mounted

A DJI Mavic 3 Multispectral drone will be used to identify and monitor the test fields. This drone, equipped with high-resolution RGB and radiometric sensors, will analyze vegetation health and provide data for the remediation system.

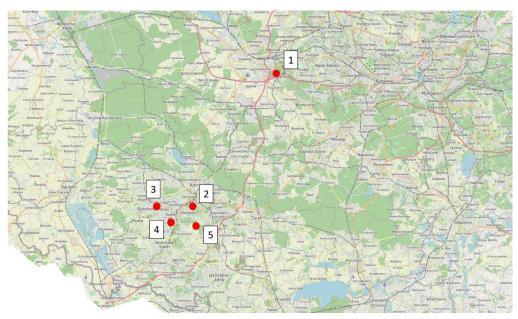
Figure 51. Chosen heaps localizations owned by PGG S.A

Preliminary selection of active or in the process of reclamation heaps belonging to the Polish Mining Group S.A. (underground mines)): Selected spoil heaps belonging to PGG, fig. 51: KWK Sośnica (1), KWK ROW Ruch Chwałowice (2), KWK ROW Ruch Rydułtowy (3), KWK ROW Ruch Marcel (4), KWK ROW Ruch Jankowice (5).

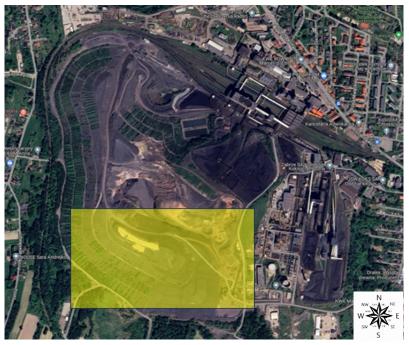
Figure 52. Selected area on the KWK ROW Ruch Marcel heap (dimensions ~600m x 350m)

Due to the capabilities (range) of the drone and the applicable legal regulations (open category A2), a fragment of the given landfill where the research area could potentially be located was registered. The following figure shows the location of a selected section of the heap, using the example of the Marcel mine (Figure 52.).

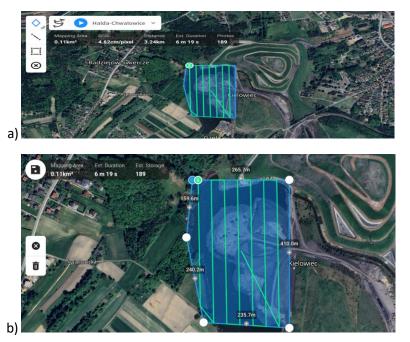
Figure 53. Path plan of global raid for KWK Chwałowice: view presenting estimated parameters as duration, resolution and count of photos (a), dimensions and area of flight (b)

After preliminary selection of the area on a given dump, dedicated flight paths for the DJI Mavic 3M UAV were developed, based on which it was possible to create orthophotomaps. An important issue was the appropriately high resolution of the obtained photos, not exceeding 5cm/pixel. Figures 53a and 53b show the flight route on the example of the waste heap of the Chwałowice mine, belonging to PGG S.A.

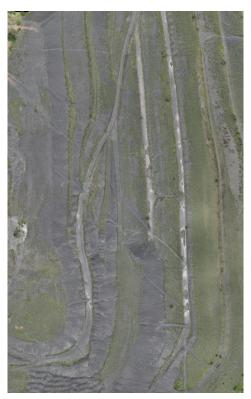
Figure 54. Global raid photos stitched into orthophotomap - KWK ROW Rydułtowy

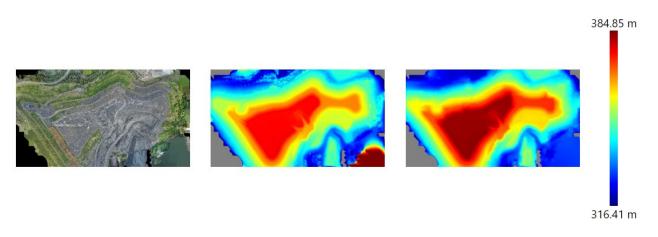
Figure 55. Geometric model of selected area of waste heap Północ of KWK Jankowice

Geometric models made it possible to develop the contours of individual dumps. On this basis, the selection of the dump and the area to be reclaimed was facilitated, so that it could be accessed by a motor vehicle with the required equipment. An example of the geometric model developed for the selected North heap, Jankowice mine, is shown in Fig 55.
